AFRPL-TR-70-43

**LONG-TERM STORABILITY
OF
PROPELLANT TANKAGE AND COMPONENTS
INTERIM REPORT #1**

R. B. MEARS, 1st LIEUTENANT, USAF

MAY 1970

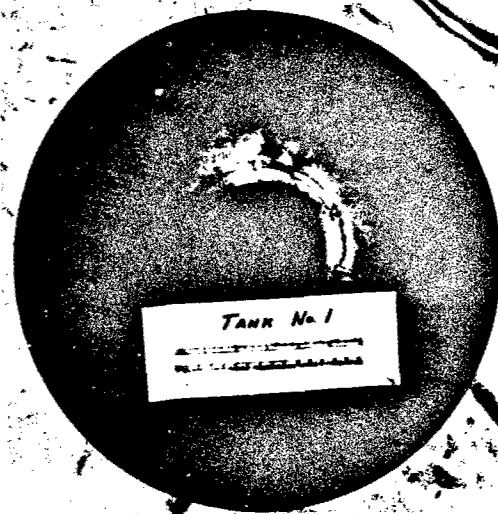
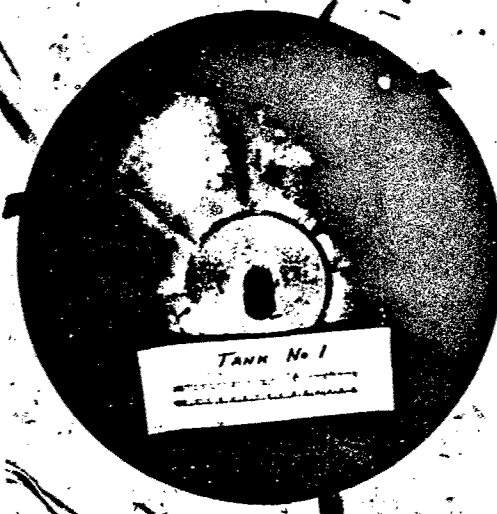
2. Leak Test - The tank was baked at 250°F for one hour. It was then pressurized with 100% helium for 30 hours. The tank was then leak checked by the hand probe method, using a CEC helium mass spectrometer. One leak was found in the bottom of the tank. This leak had a magnitude of 8.4×10^{-6} atm. cc/sec. One leak having a magnitude of 1.6×10^{-9} was also found in the top of the tank, Figure 2.

Figure 2. Leak Areas of Tank No. 1
0.2X (Shown by Arrows)

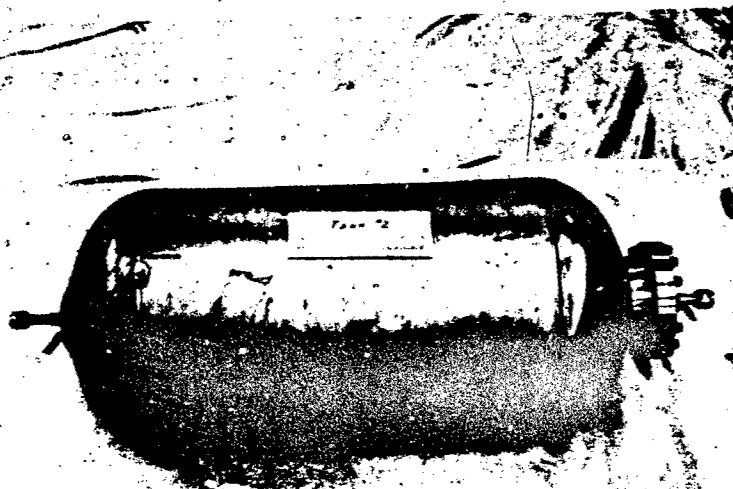
Figure 1. Side View of Tank No. 2

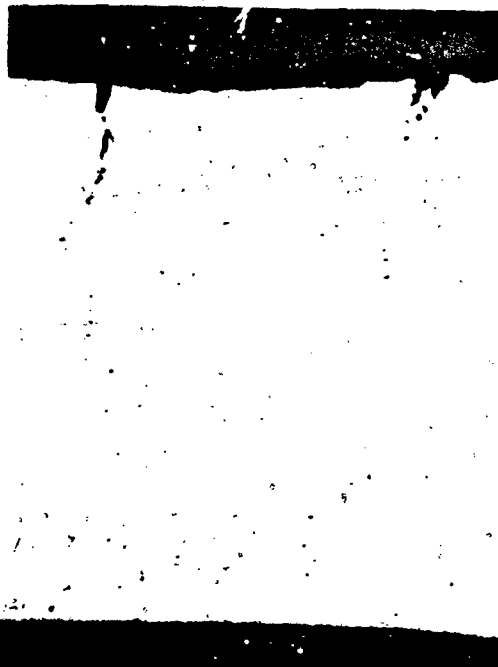
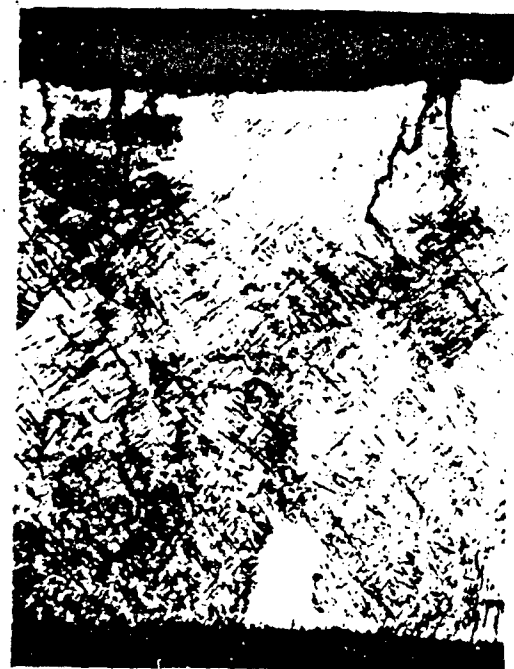
Figure 7. Stress-Corrosion Cracks and Alpha Case in Discolored Area, Unetched and Etched. (100X)

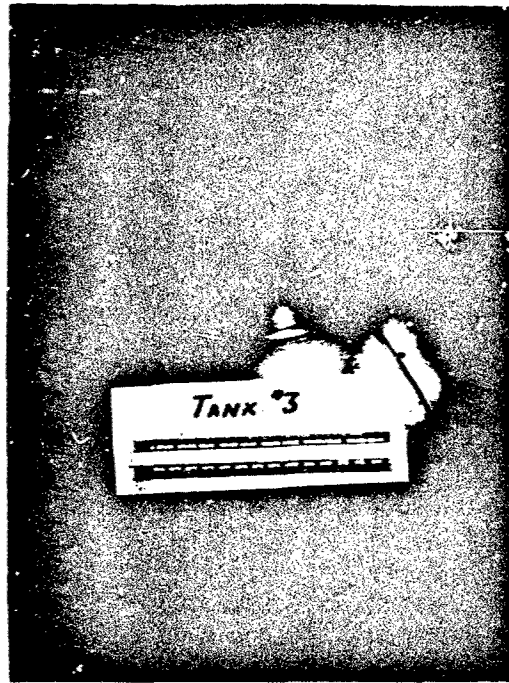
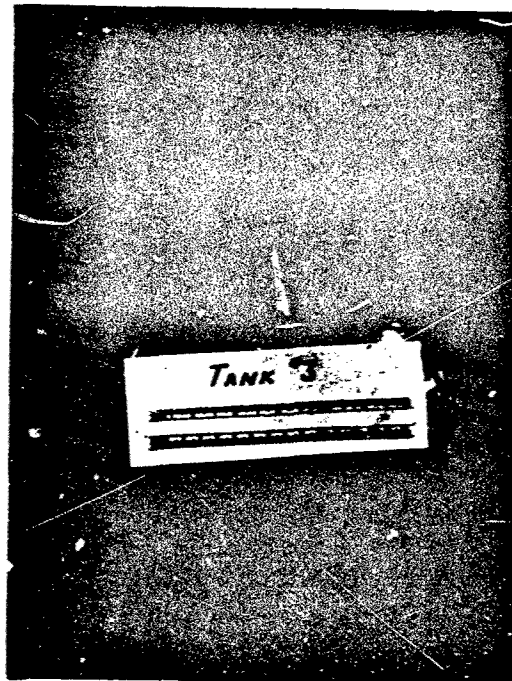
Figure 3. End Views of Tank No. 3

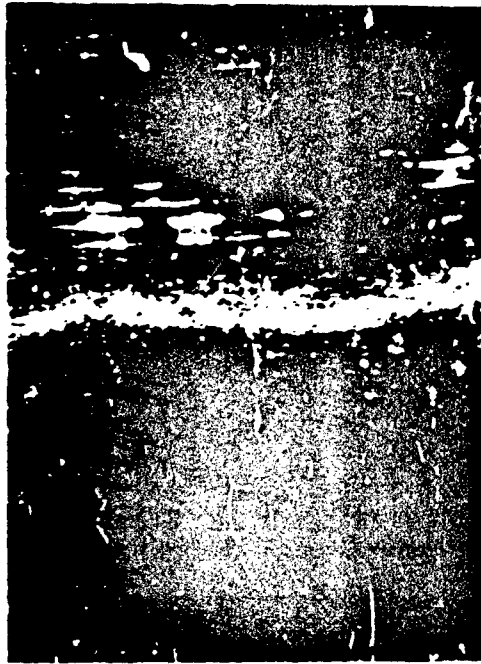
Figure 4. Photomacrograph Showing the Appearance of the Inside Surfaces of Tank Serial No. 3 (20X)

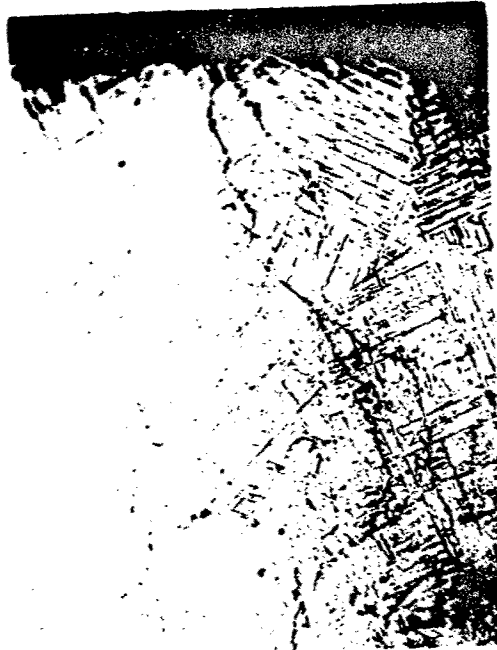
Figure 6. Photomicrograph Showing the Microstructure of the Ti-6Al-4V Titanium Alloy at a Stress Corrosion Crack (250X)

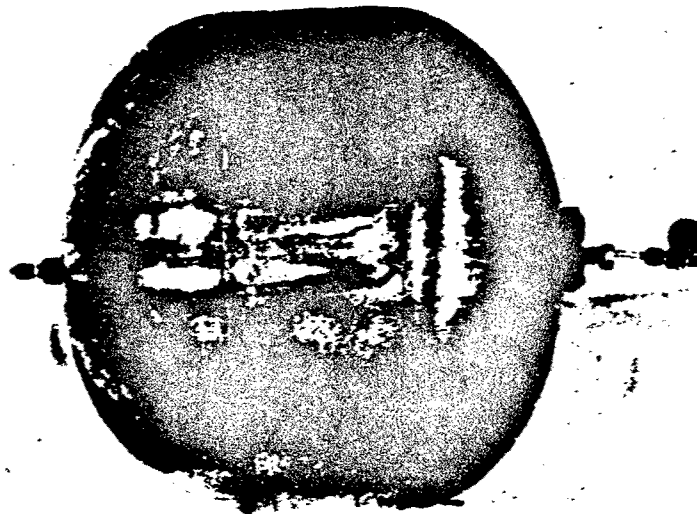
Figure 1. Photomicrograph Showing the Overall Appearance of the Failed AM350 Small Tank A/F Serial No. 4 1/4X

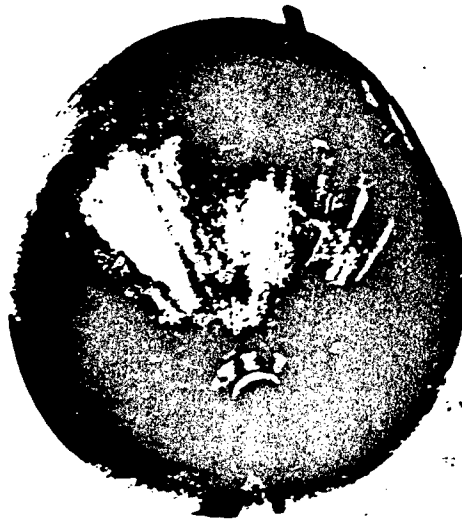
Figure 3. Photomacrograph Showing the Bottom End of the Failed Tank. 1/4X

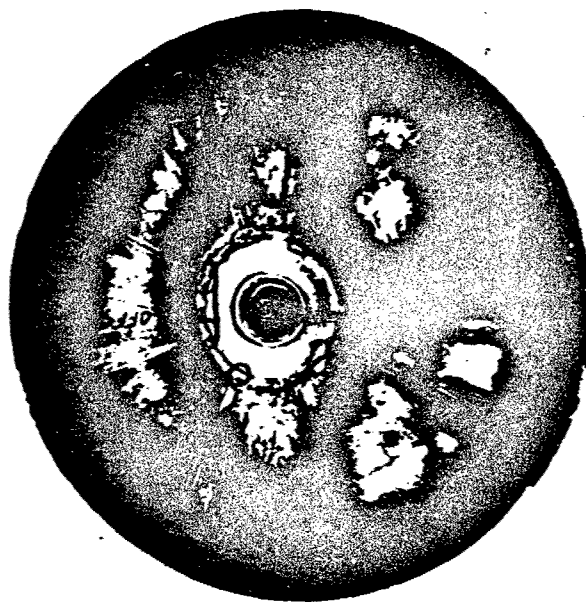
Figure 5. Photomicrograph Showing the Leak Areas on the Bottom of the Failed Tank. 1/4X

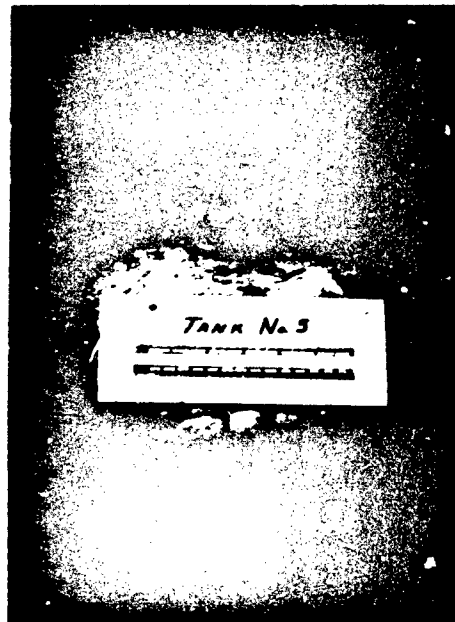
Figure 1. Crack in Outlet Flange of S/N 5 1/4X

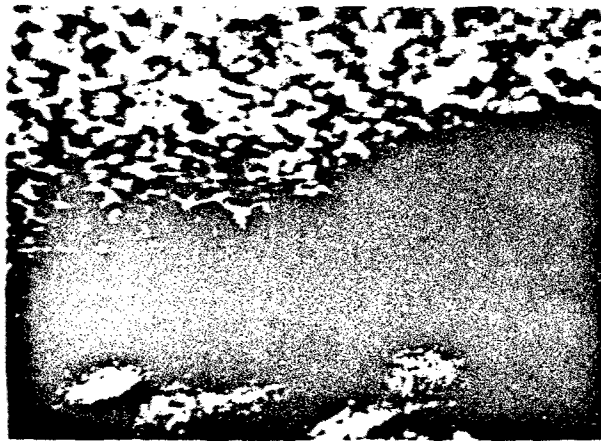
Figure 9. Photomacrograph of Crack Near Fusion Weld. (20X)

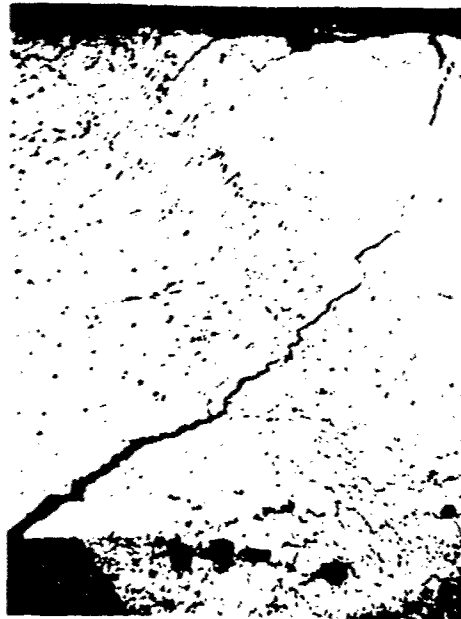
Figure 10. Microsection Through Hot-Short Crack in Figure 9. (50X)

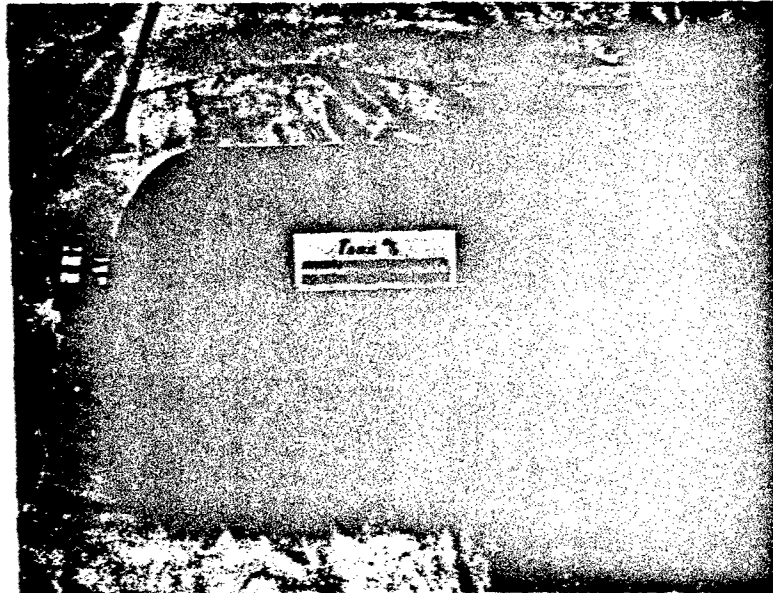
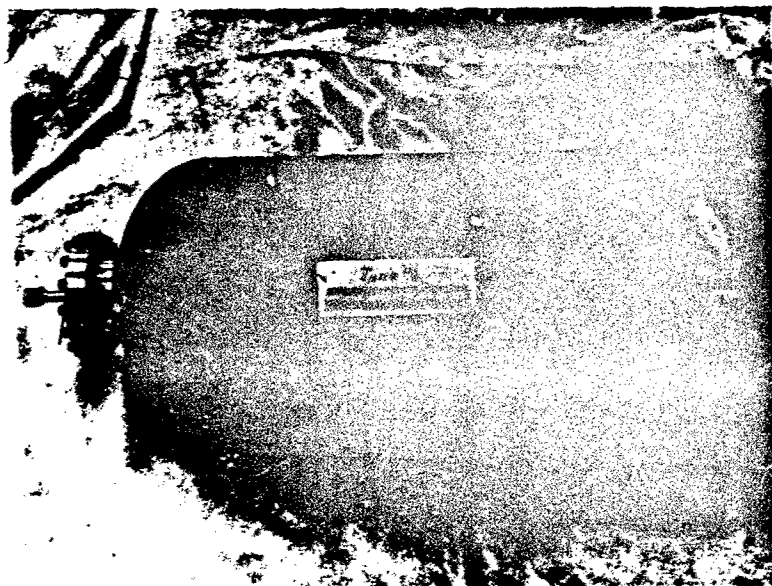
Figure 1. Side views of Tank No. 6.

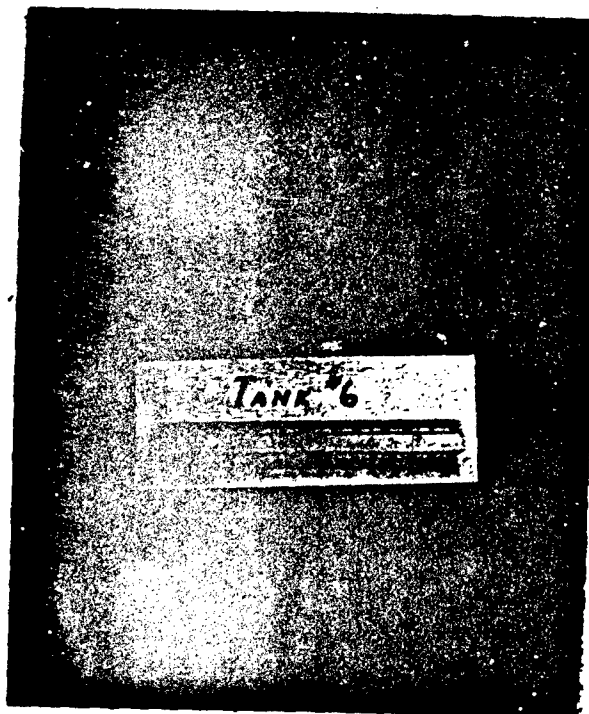
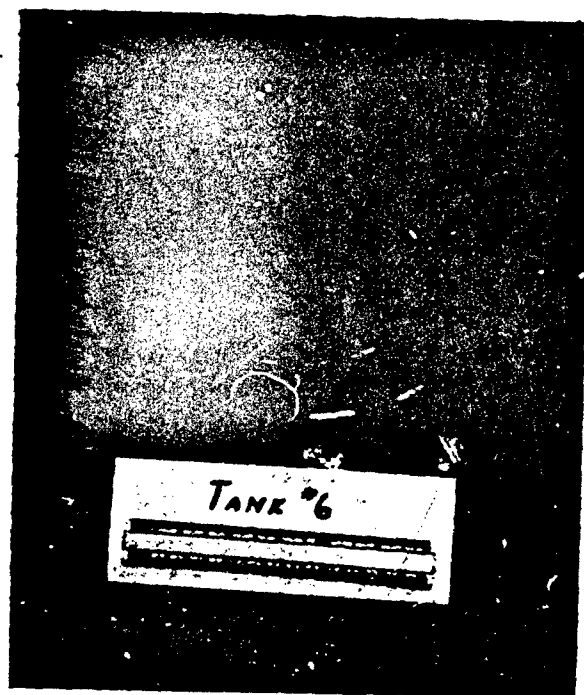
Figure 2. End views of Tank No. 6.

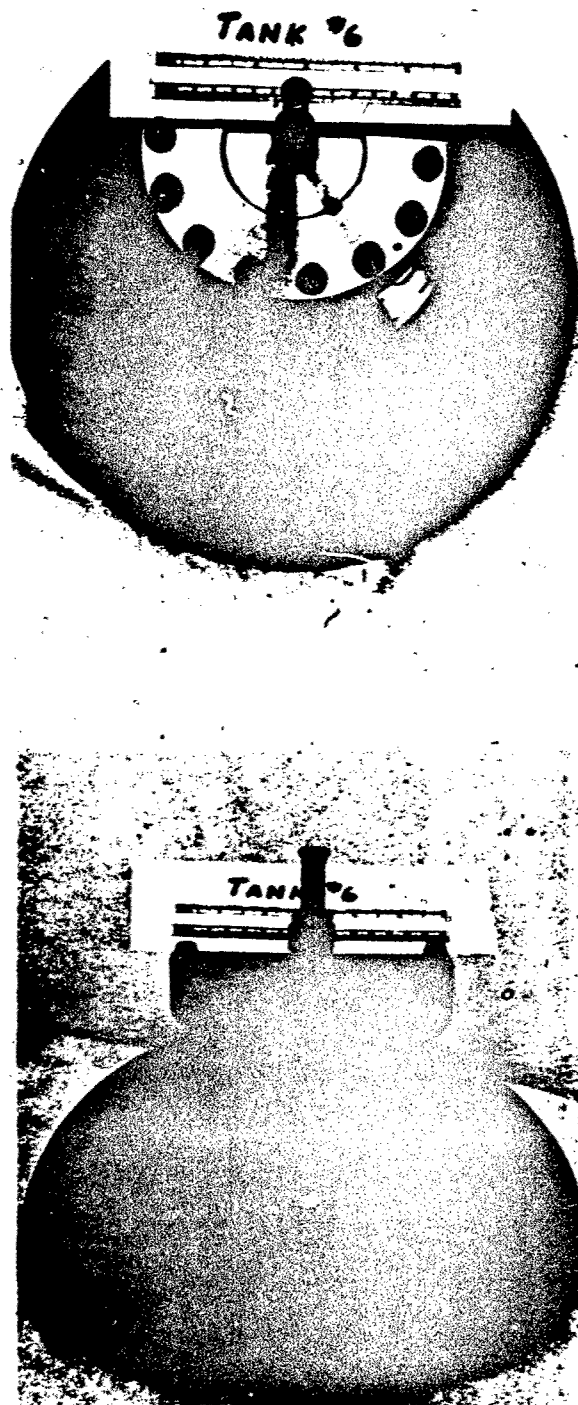
Figure 3. Flanged End of Tank No. 6.

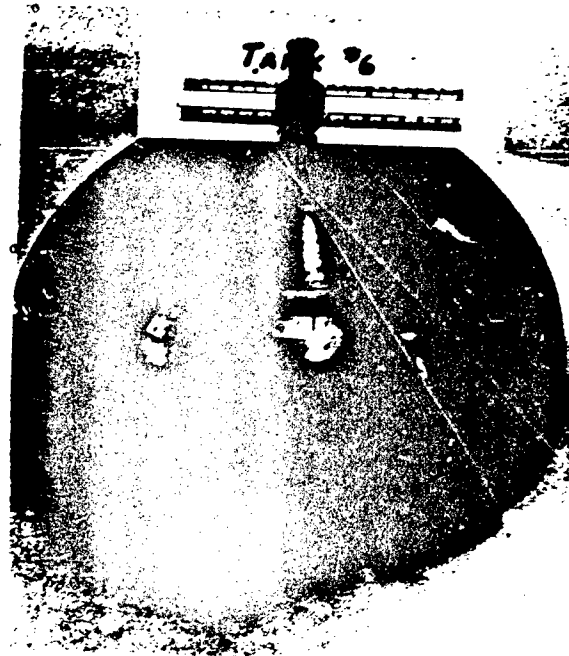
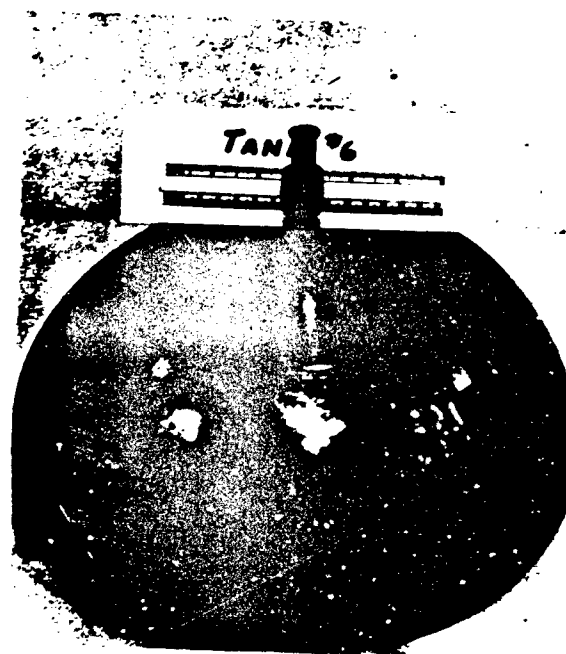
Figure 4. "Eenie" End of Tank No. 6.

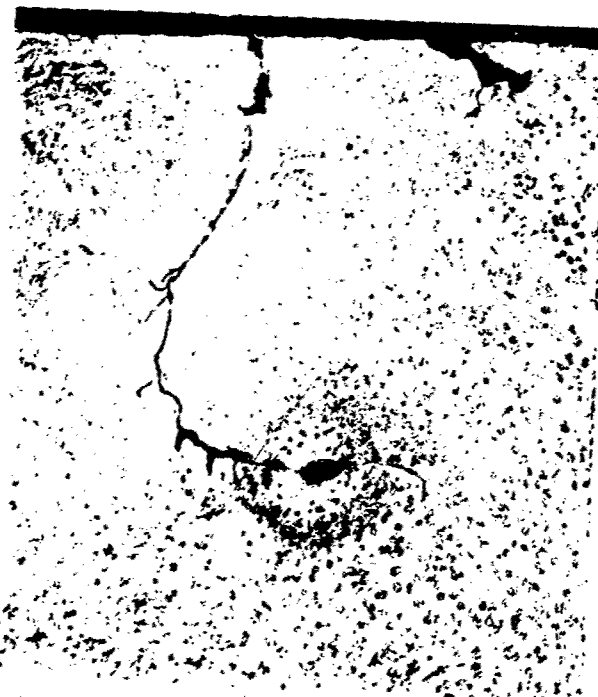
It was apparent from the microsections that all of the leaks except one were caused by external corrosion. One leak apparently occurred through a hot-short crack in a dome weld, Figure 6.

4. X-ray Examination - The dome welds from both ends of the tank were x-rayed. In addition to the corrosion pits, three hot-short cracks were visible in the weld x-rays.
5. Mechanical Tests - Tensile specimens were taken longitudinally from the barrel section of the tank. The following properties were obtained.

Figure 6. Photomicrograph of Hot-Short Crack
in Dome Weld Area of Tank No. 6.
75X

1. Test conditions should be regulated so that when other test specimens fail, the by-products of that failure should not be allowed to interfere with another test in progress.
2. Weld acceptance criteria used to initially accept this tank should be reviewed for future orders. The criteria should be strengthened in the area of acceptable radiographic defects.
3. Weld parameters must be adjusted on initial qualifications and certifications to assure that the production articles will be free from hot tearing.

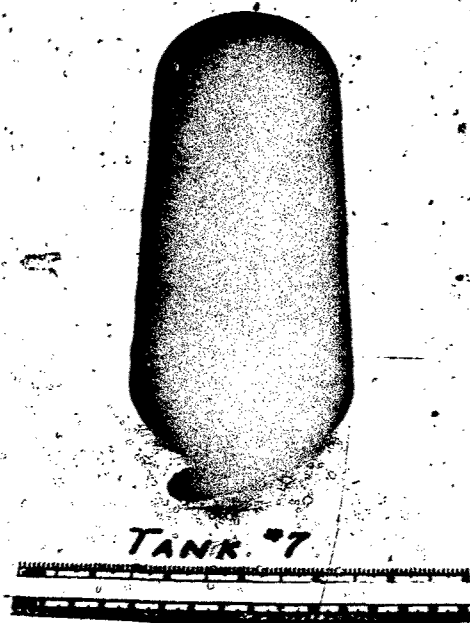
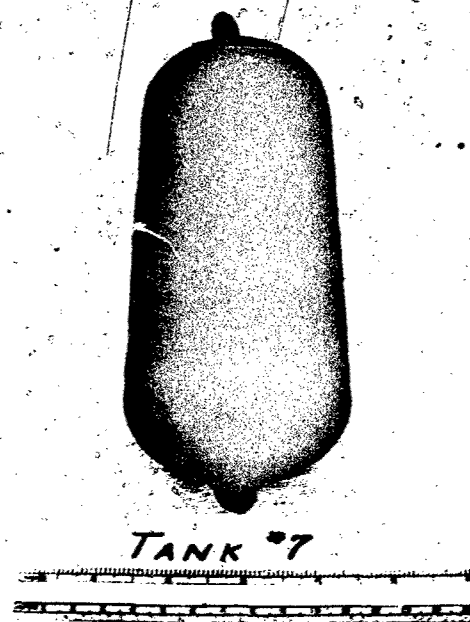
1. Macroexamination - The tank had been lightly etched over its whole external surface, Figures 1 and 2. Numerous stress-corrosion cracks were found in the HAZ of the boss weld on one end of the tank, and severe corrosion pits were found in the weld, Figure 3.

Figure 2. Endviews of Tank Number 7. 1/2X

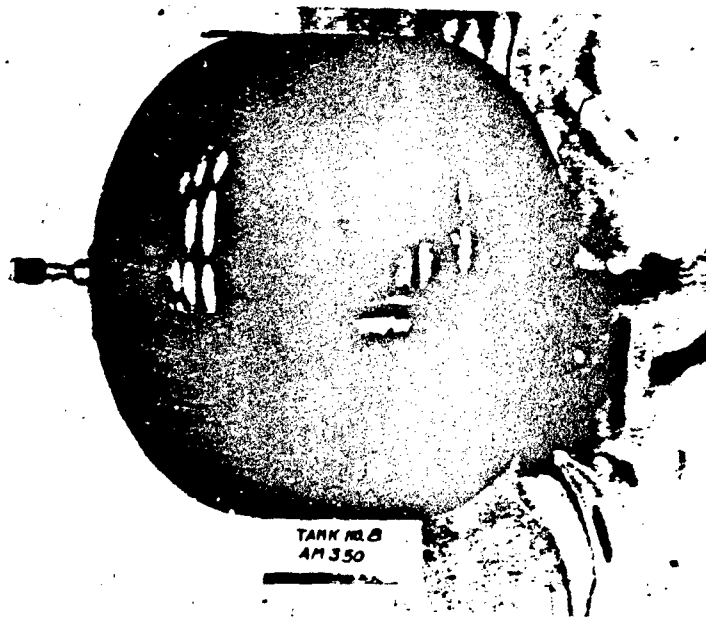
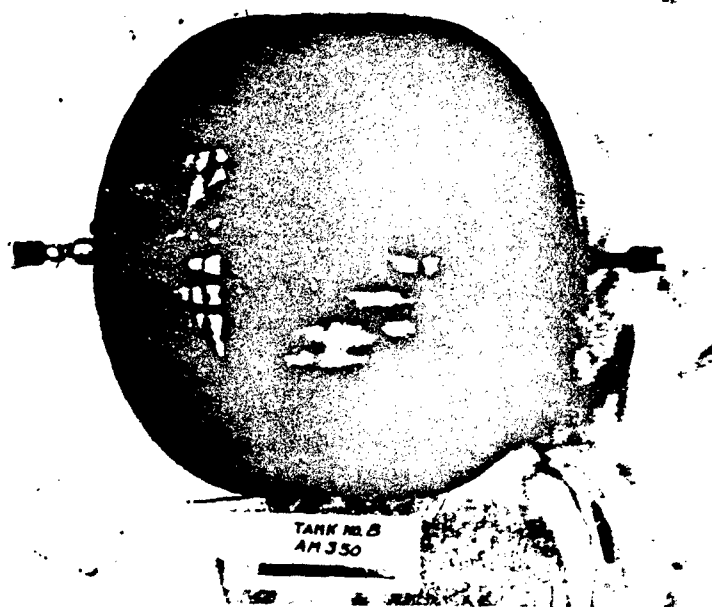
Figure 1. Sideview of Tank Serial No. 8. Representative Photomacrographs Showing General Corrosion. Top of Tank Is To The Left of The Photograph. Approximately 1/4X magnification.

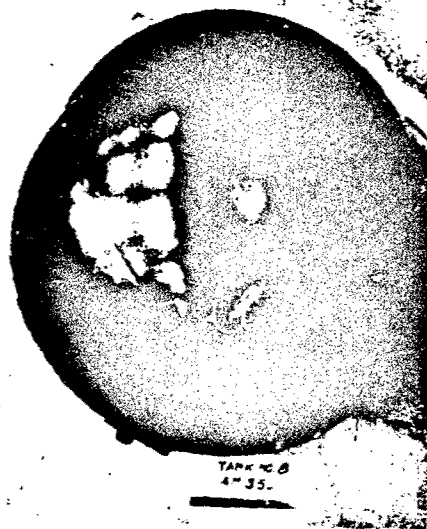
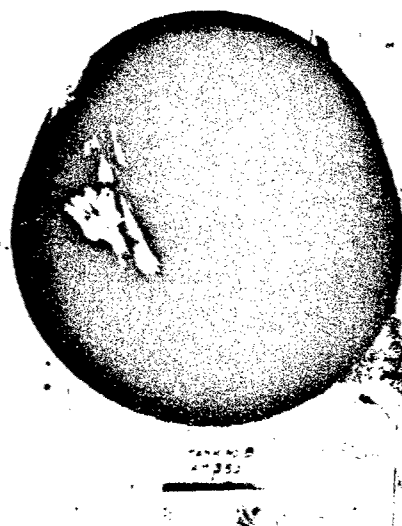
Figure 2. Top and Bottom View of Tank Serial No. 8. Representative Photomacrographs Showing General Corrosion. Approximately 1/4X Magnification.

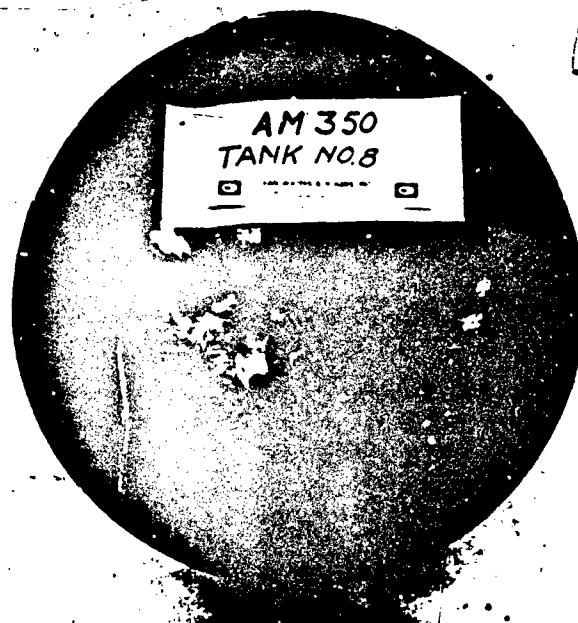
Figure 3. A Photomicrograph Showing The Two Leak Areas in Bottom of Tank Serial No. 8. Approximately 1/4X Magnification.

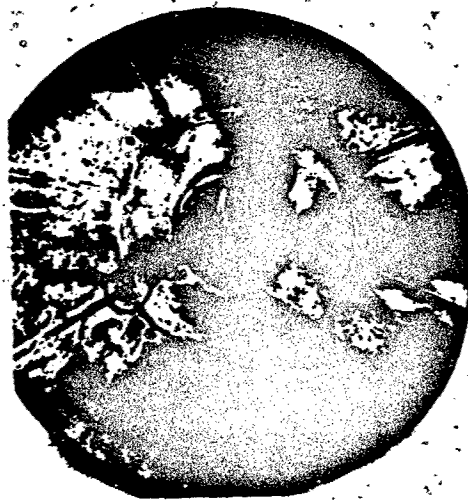
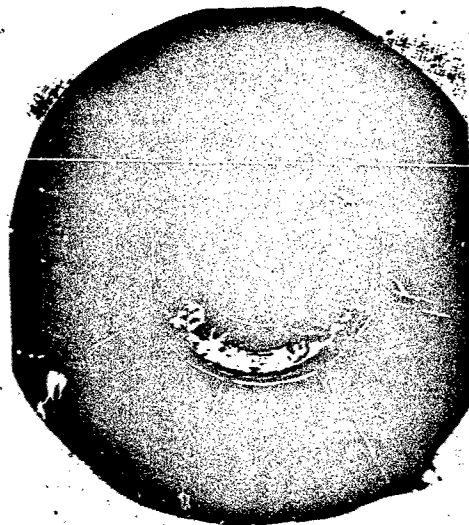
AM350 TANK NO. 8

Figure 8. Photomicrograph Showing The Appearance of The Inside and Outside of Leak Area of Tank Serial No. 8. 1/3X Magnification.

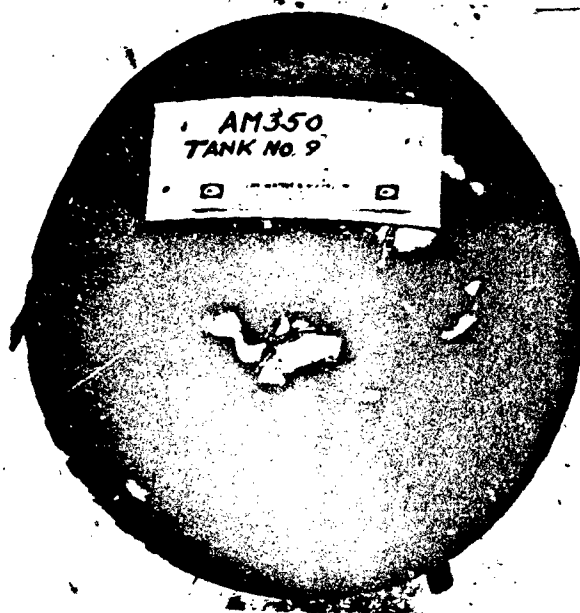
Figure 1. Top View of Tank No. 9.

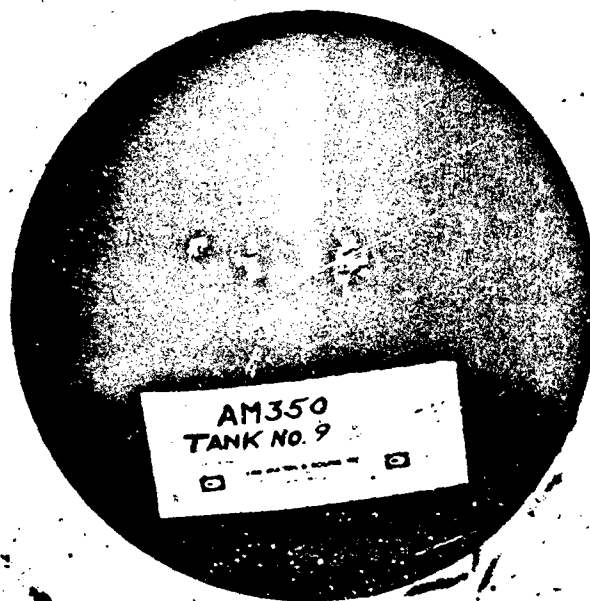
10. The 85% relative humidity and close proximity of this tank to a leaking N_2O_4 vessel, resulted in condensation of HNO_3 on the top of the tank, and caused tank S/N 9 to leak. The HNO_3 then drained down the sides of the tank and concentrated on the bottom. Corrosion occurred generally over the outer surfaces of the tank and heavy pitting occurred on the bottom of the tank with two pits penetrating the wall thickness of the tank. Actually, HNO_3 is the suspected oxidizing acid that caused corrosion in this case since there were no fluorides or significant amounts of chlorides present in the corrosion residue.

Figure 2. Bottom View of Tank No. 9.
Circled areas are leaks.

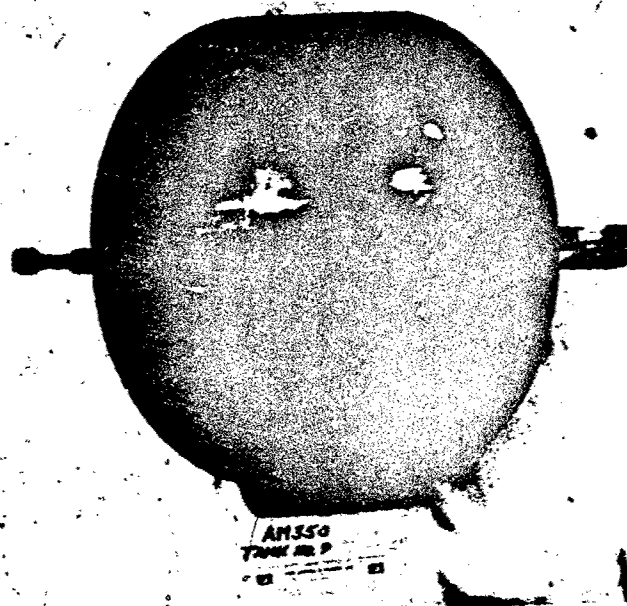
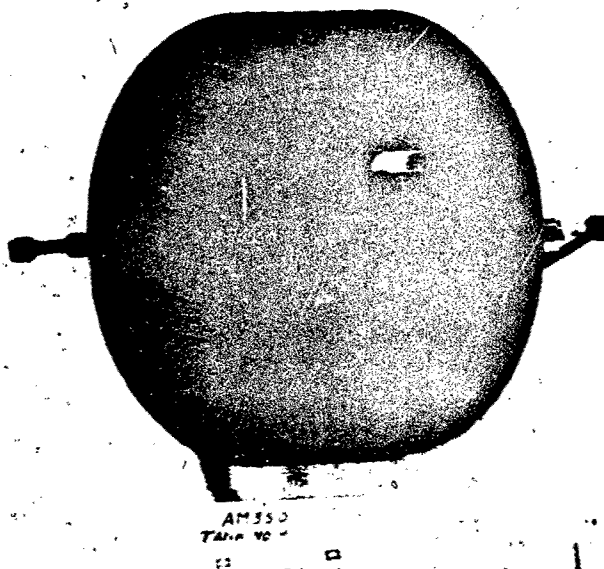
Figure 3. Side Views of Tank No. 9.

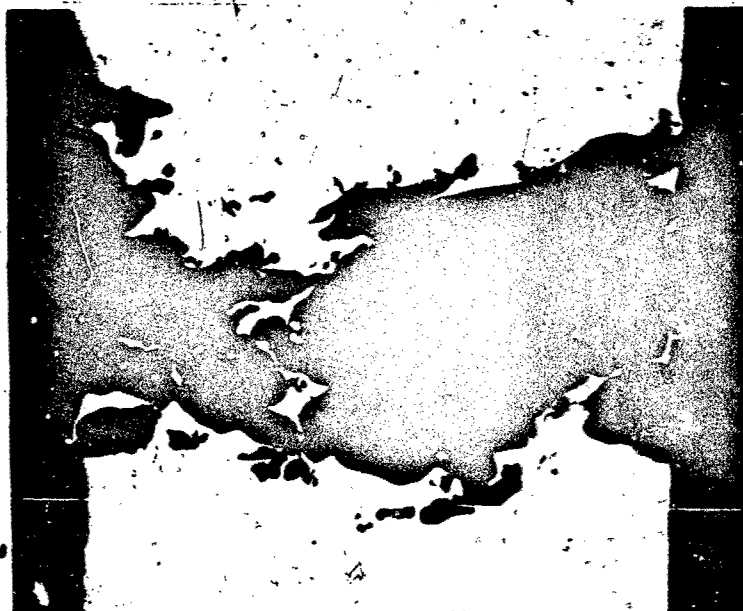
Figure 6. Photomicrograph Similar to Figures 4 and 5. 100X

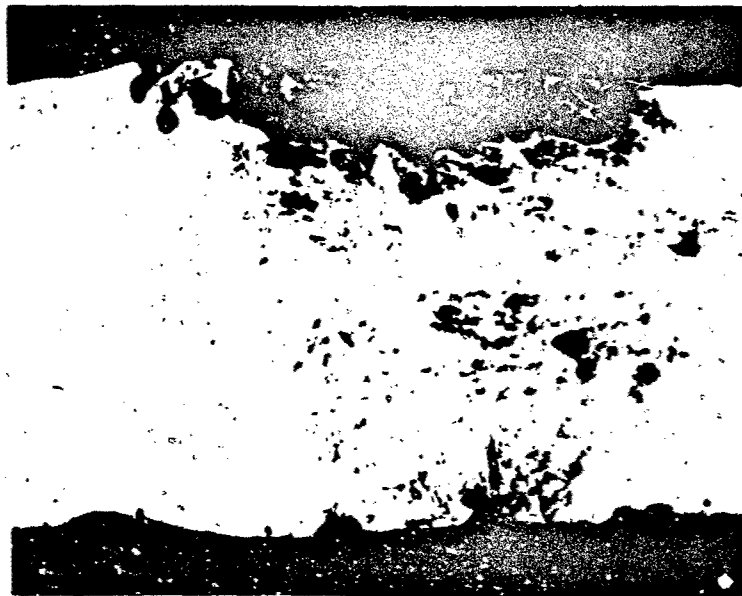
Figure 7. Photomicrograph Similar to Figures 4, 5 and 6. 100X

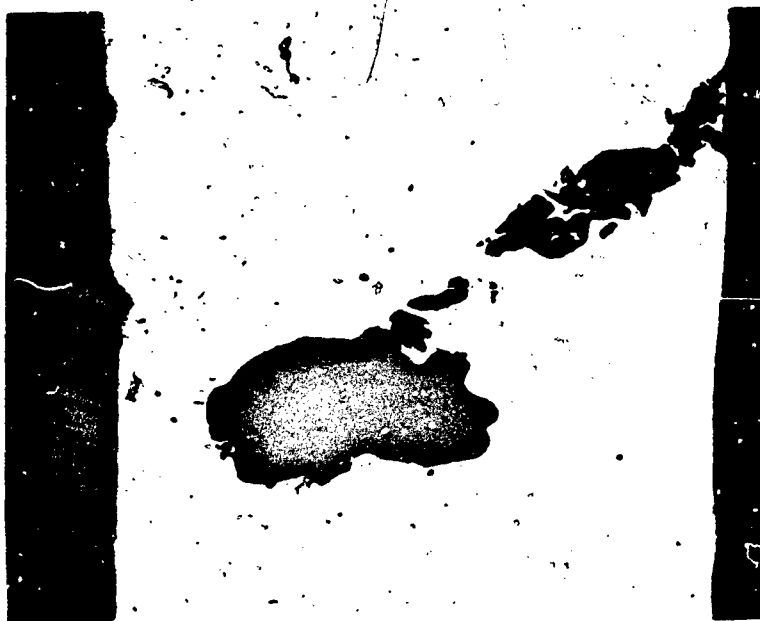
Figure 8. Photomicrograph Similar to Figures 4, 5, 6 and 7. 100X

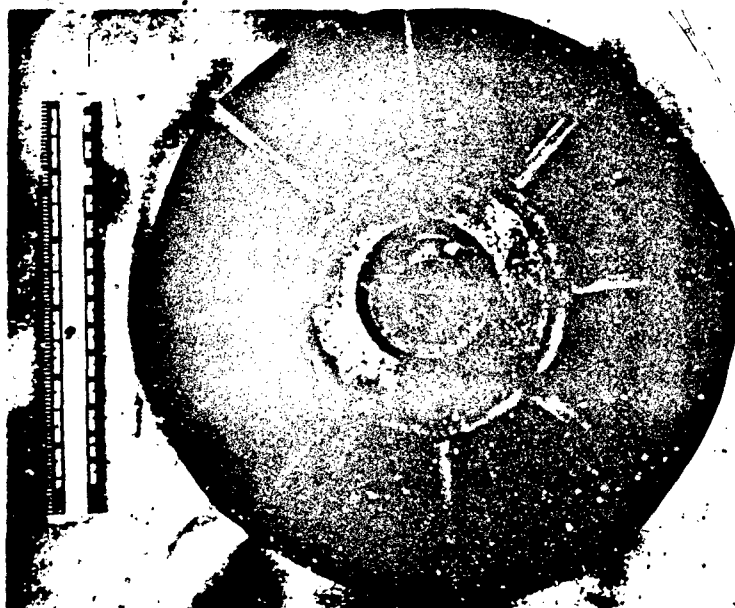
9. Internal Tank Examination - The inside of the tank was discolored and appeared to have been slightly corroded, Figure 9. This amount of corrosion could have easily occurred after the tank was depressurized and stored under ambient conditions and apparently was not a result of corrosion during storage conditions.

Figure 9. Photomacrograph Showing an Inside View of the Dome Area of Tank Serial No. 9. Approx. 1/3X

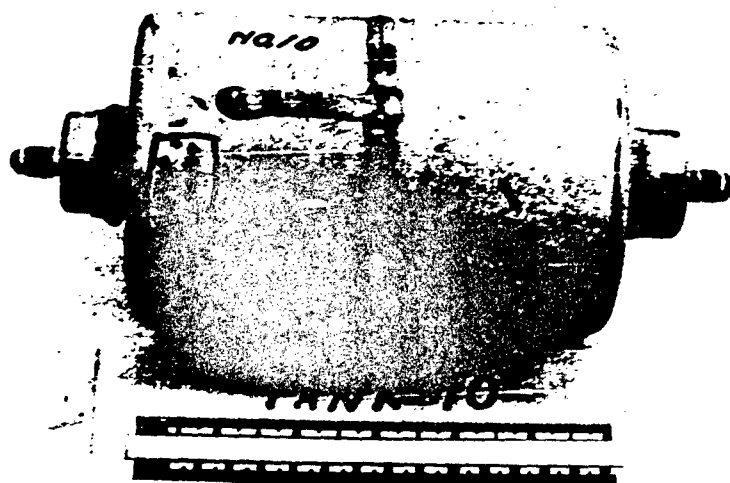
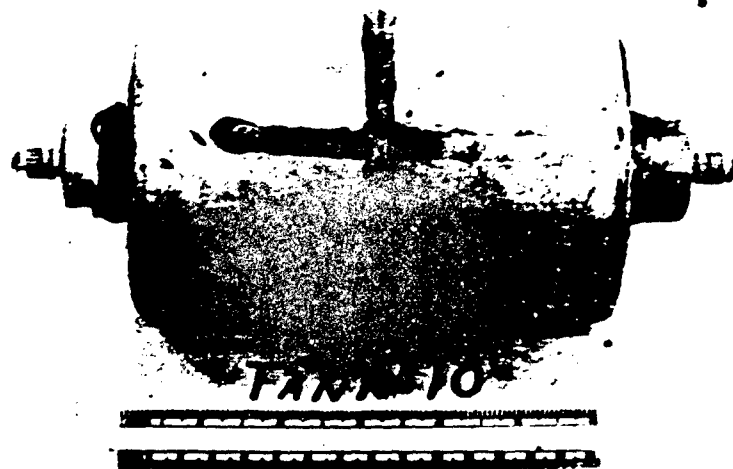
Figure 1. Sideviews of Tank No. 10. 1/2X

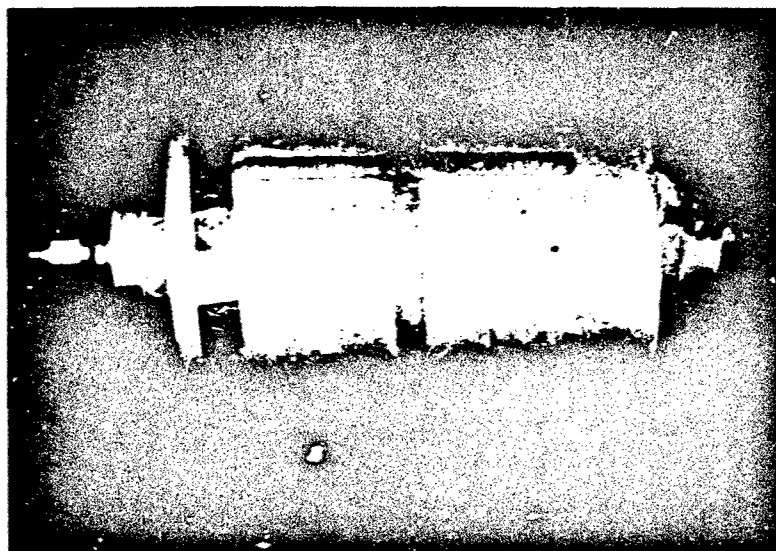
Figure 1. Photomicrograph showing overall sideview of small tank no. 11. Top of tank is shown to the right. 0.6X

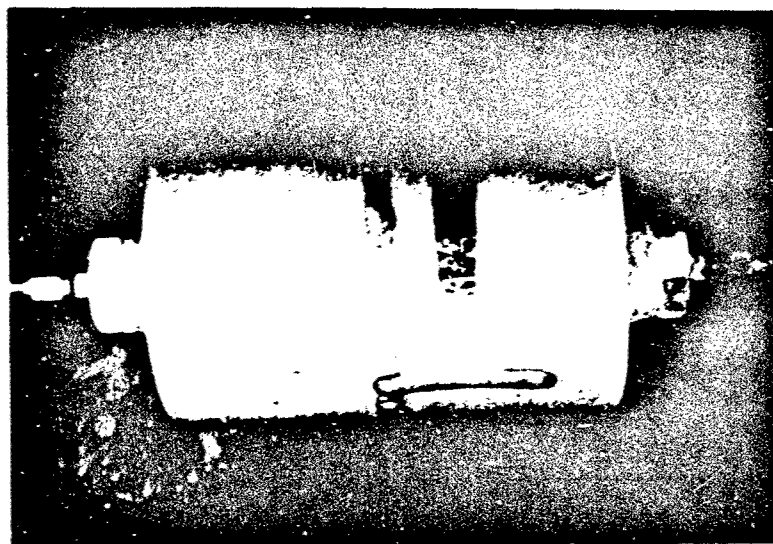
Figure 2. Photomicrograph showing overall sideview of small tank no. 11. Top of tank is shown to the right.

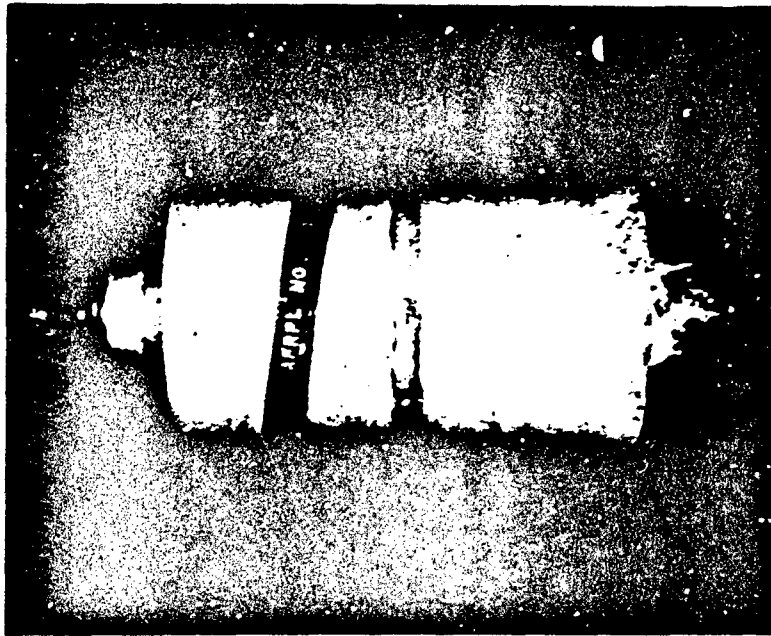
Figure 3. Photomicrograph showing overall sideview of small tank no. 11. Top of tank is shown to the right. 0.6X

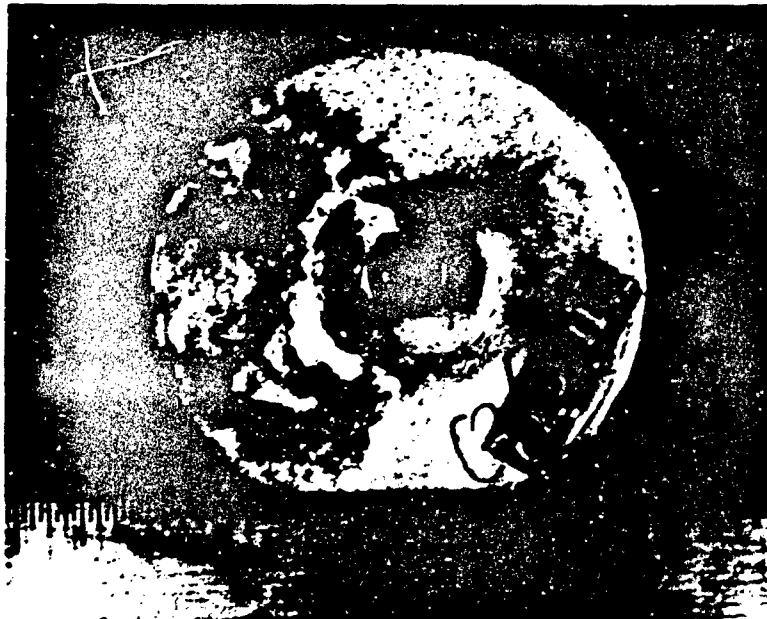
Figure 4. Photomicrograph showing overall view of the top end of small tank no. 11 0.75X

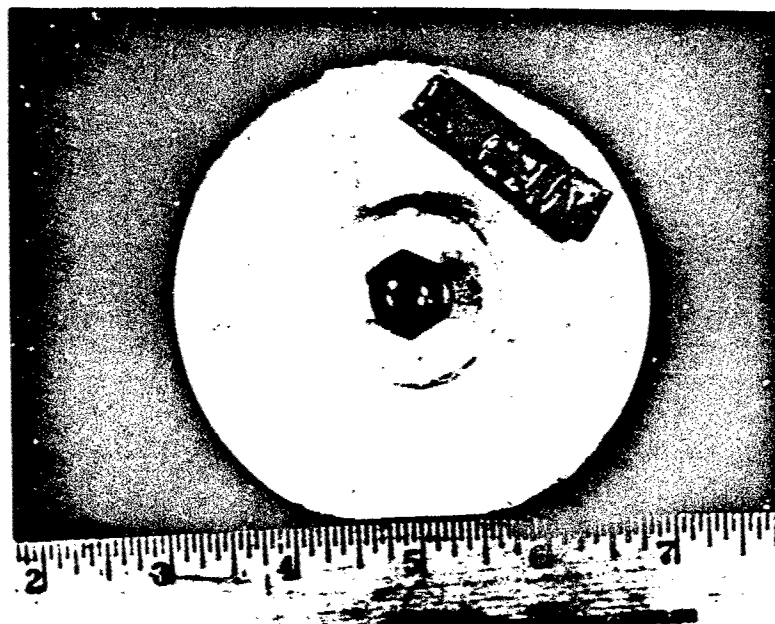
Figure 5. Photomacrograph showing an overall view of the bottom of small tank no. 11 0.75X

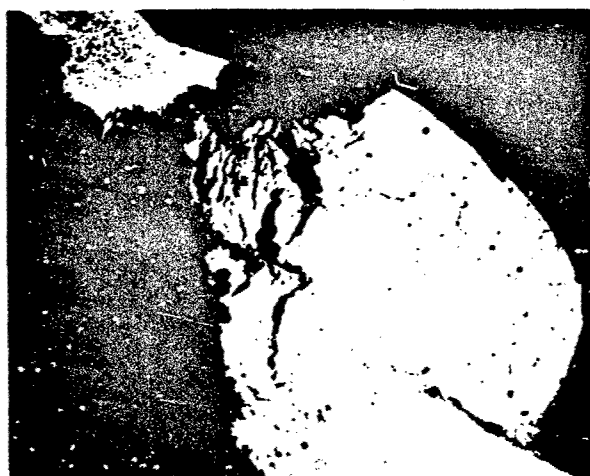
Figure 10. Photomicrograph showing intergranular corrosive attack in weld zone of tank no. 11, in the 92x1000 leak area. 10X

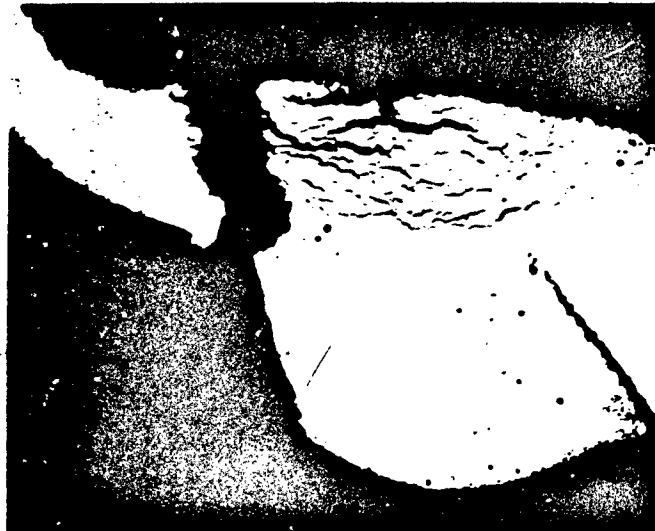
Figure 11. Photomicrograph showing intergranular corrosion in the heat affected zone and weld bead of small tank no. 11, in the 19x500 leak area. 10X

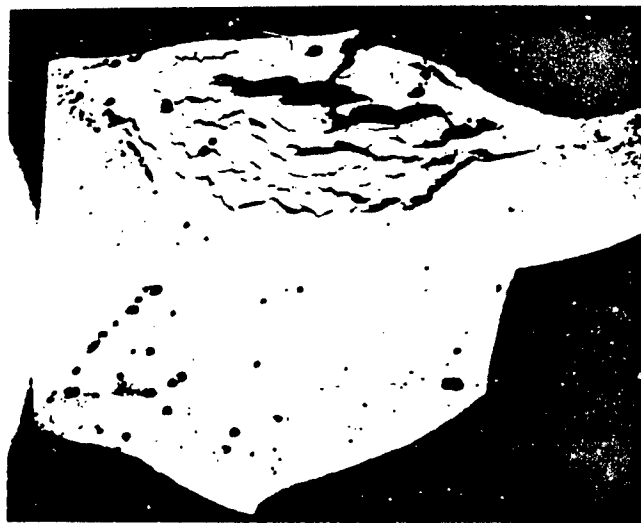
Figure 12. Photomicrograph showing intergranular corrosion in the weld stop area of small tank no. 11, in the 42x1 leak area. 10X

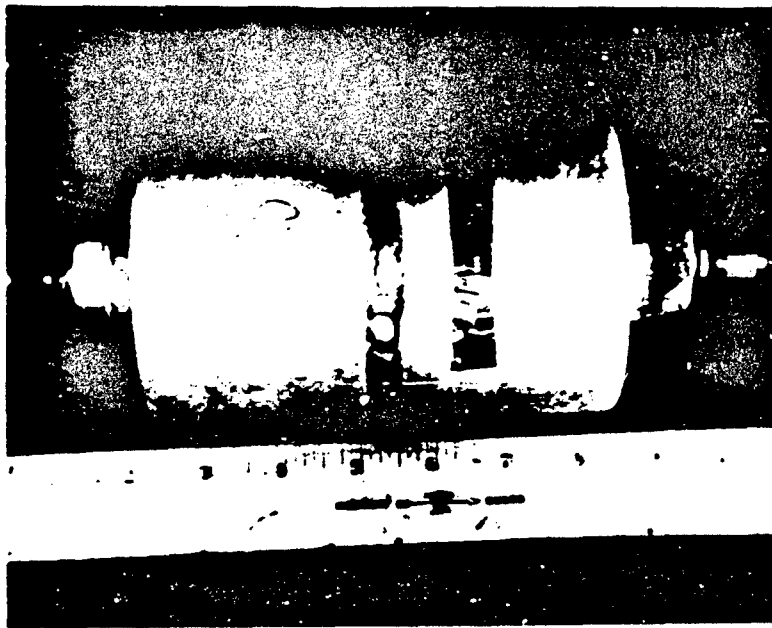
1. Macroexamination - The tank was lightly etched over its entire surface, Figures 1, 2, and 3. The tank was severely corroded in the area of the fitting welds, Figures 4, 5, and 7. The weld cross-over areas in the main tank body were not severely attacked, but the start area of the girth weld was cracked, see Figure 6. Significant acid etching was observed on the bottom fitting weld as shown in Figure 7. Figure 8 shows cracking as a result of intergranular corrosion in the stop area of the top fitting weld.

Figure 1. Photomicrograph showing overall sideview of small tank no. 12. Top of tank is shown to the right. 0.6X

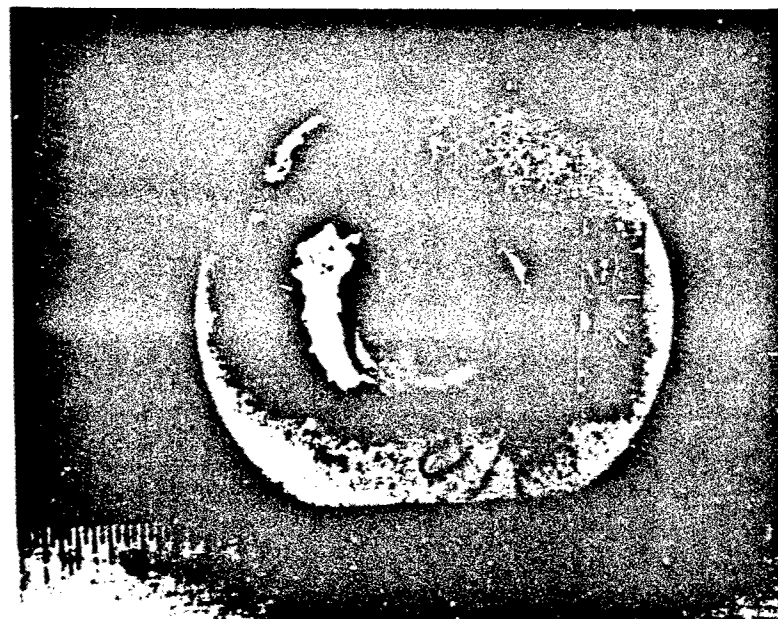
Figure 3. Photomacrograph showing overall sideview of small tank no. 12. Top of tank is shown to the right. 0 6X

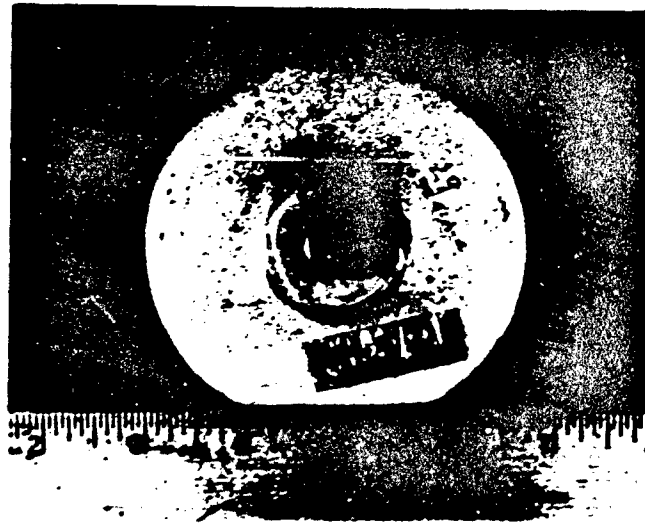
Figure 4. Photomacrograph showing and overall view of the top end of small tank no. 12. 0.75X

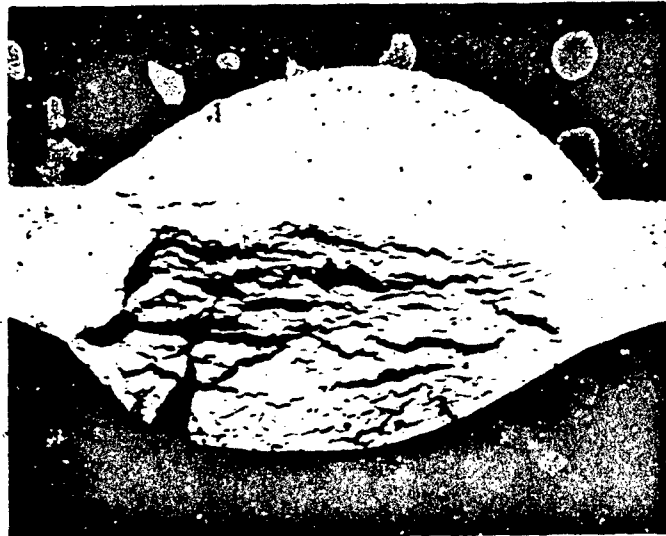
Figure 8. Photomacrograph showing the leak area in the fitting-to-end cap weld in the bottom of small tank no. 12. 1.5X

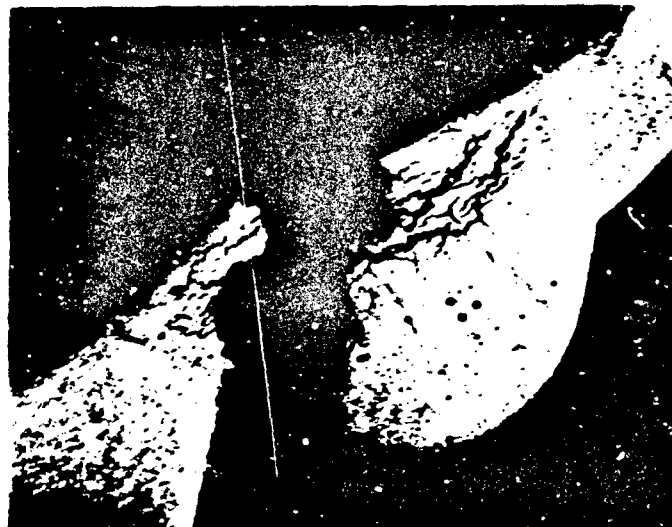
Figure 9. Photomicrograph showing heavy intergranular corrosion attack in the weld zone of small tank no. 12, in the 72 x 10 leak area. 10X

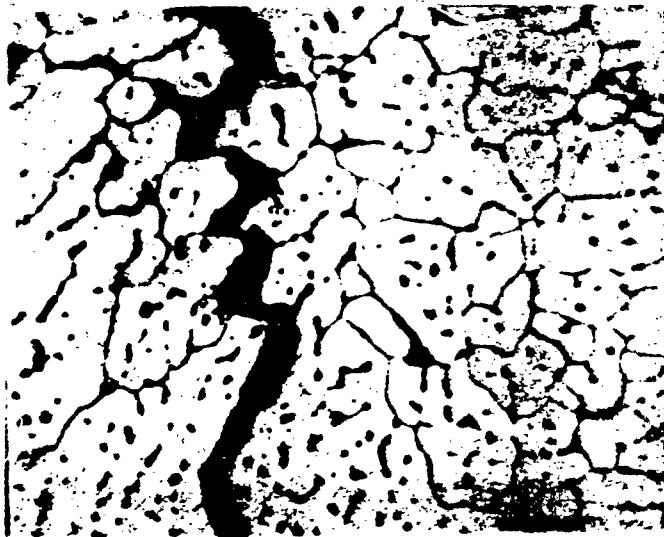
Figure 12. Photomicrograph showing the same relative area as Figure 11 after further polishing to expose the leakpath. 10X

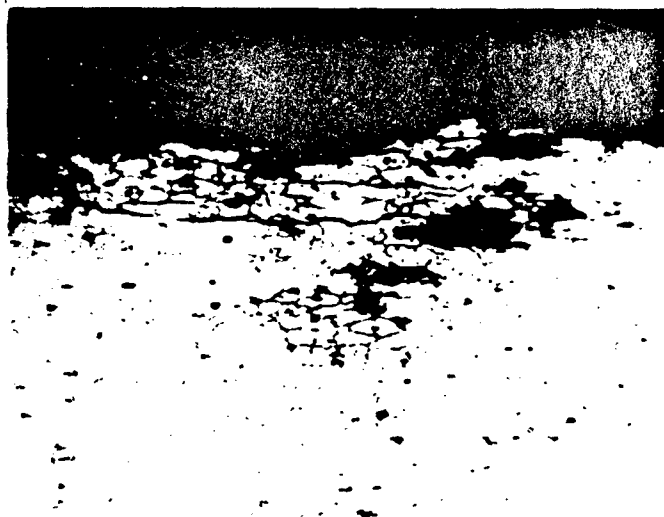
Figure 13. Photomicrograph showing representative intergranular corrosion through the weld area of the 32 x 10 leak area in small tank no. 12. 200X
